Site Visit Report

Project: Bushkill Creek Stream Restoration Project

Location: Palmer Township near Stockerton, PA

Purpose of Visit: Observe Geophysical Investigation

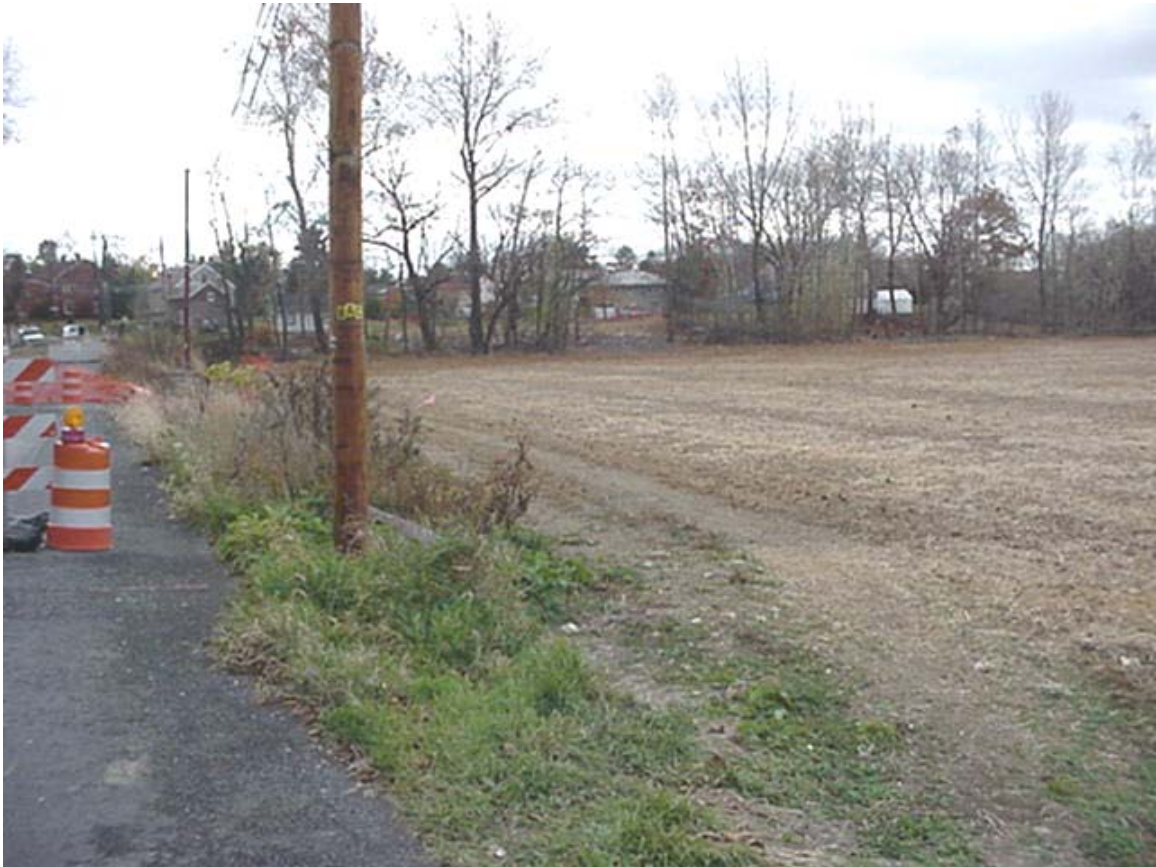
View looking southwest across the soybean field immediately north of the Bushkill Creek area investigated during this EI survey. SR 2017 is to the left in this photograph.

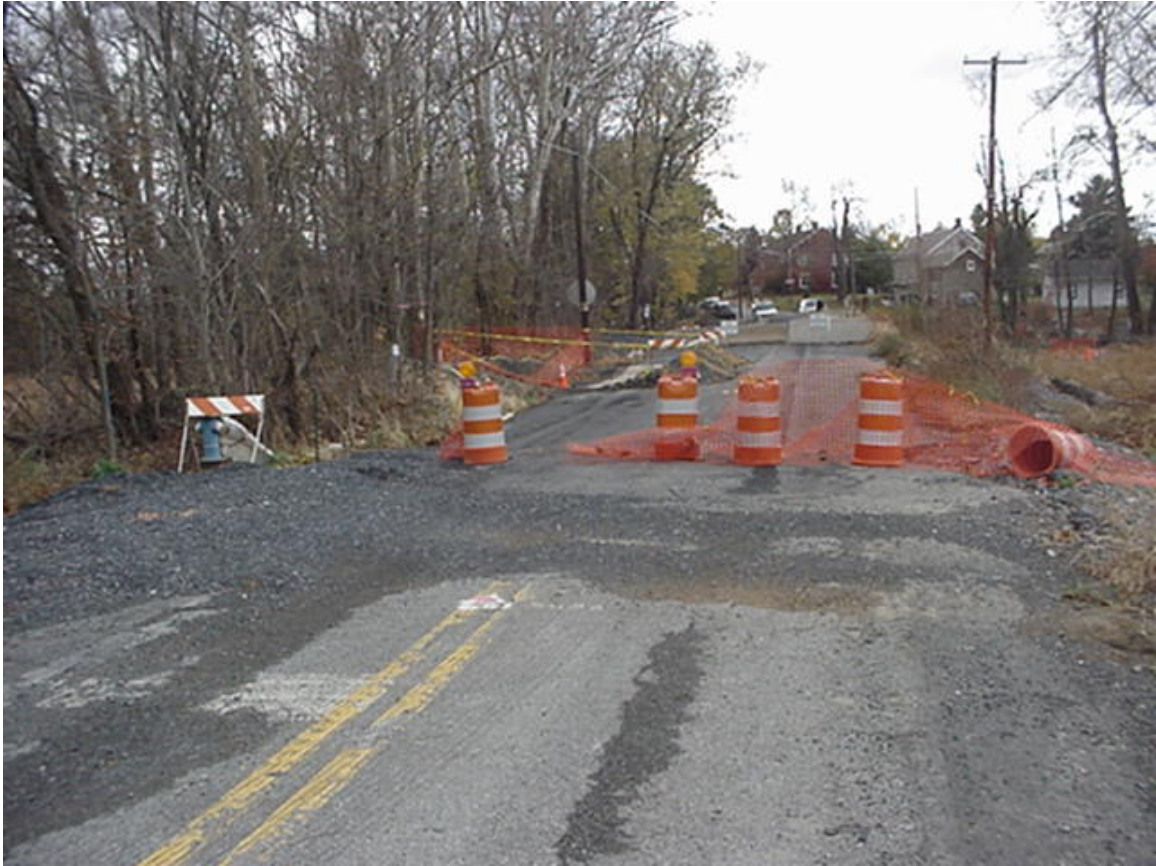
View looking south along SR 2017 towards the collapsed bridge.

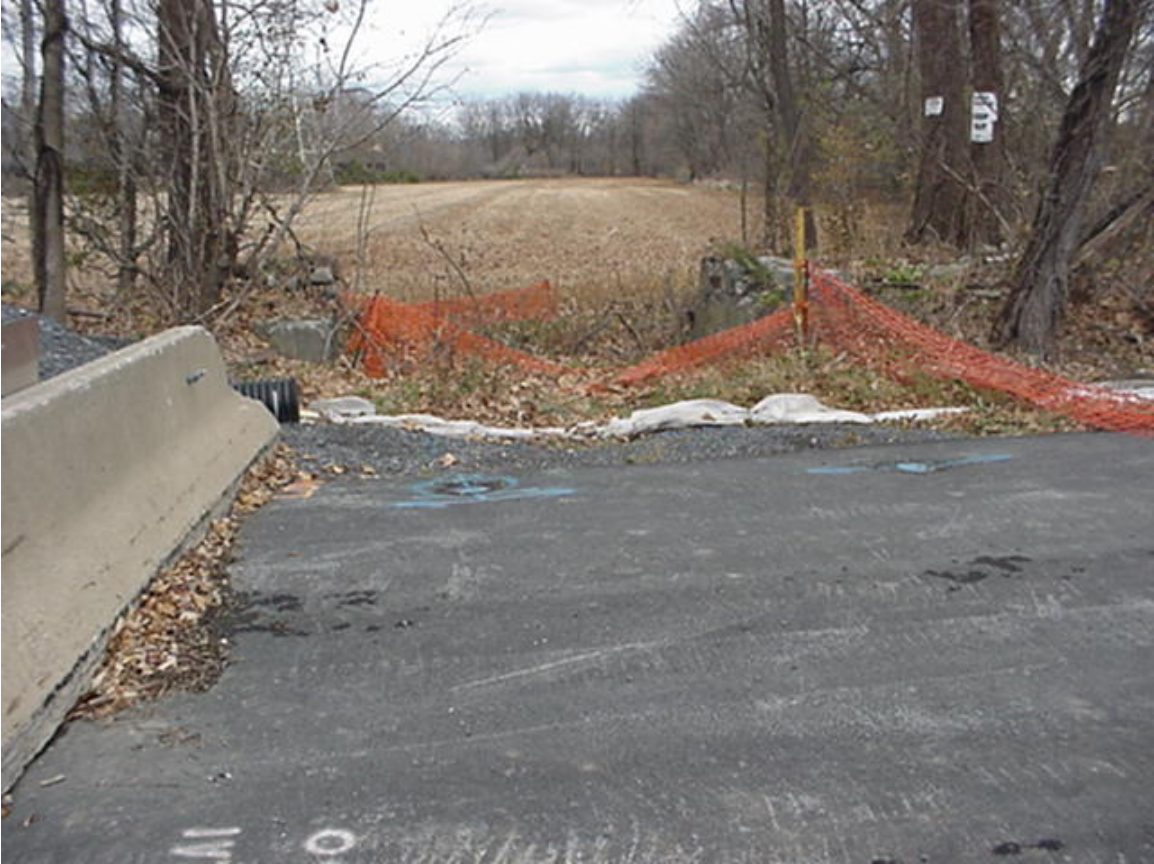
View looking east across the northern end of bridge approach area. A sinkhole was previously observed and filled just beyond the roadway. PADOT's EI survey indicated the presence of low conductivity in this area.

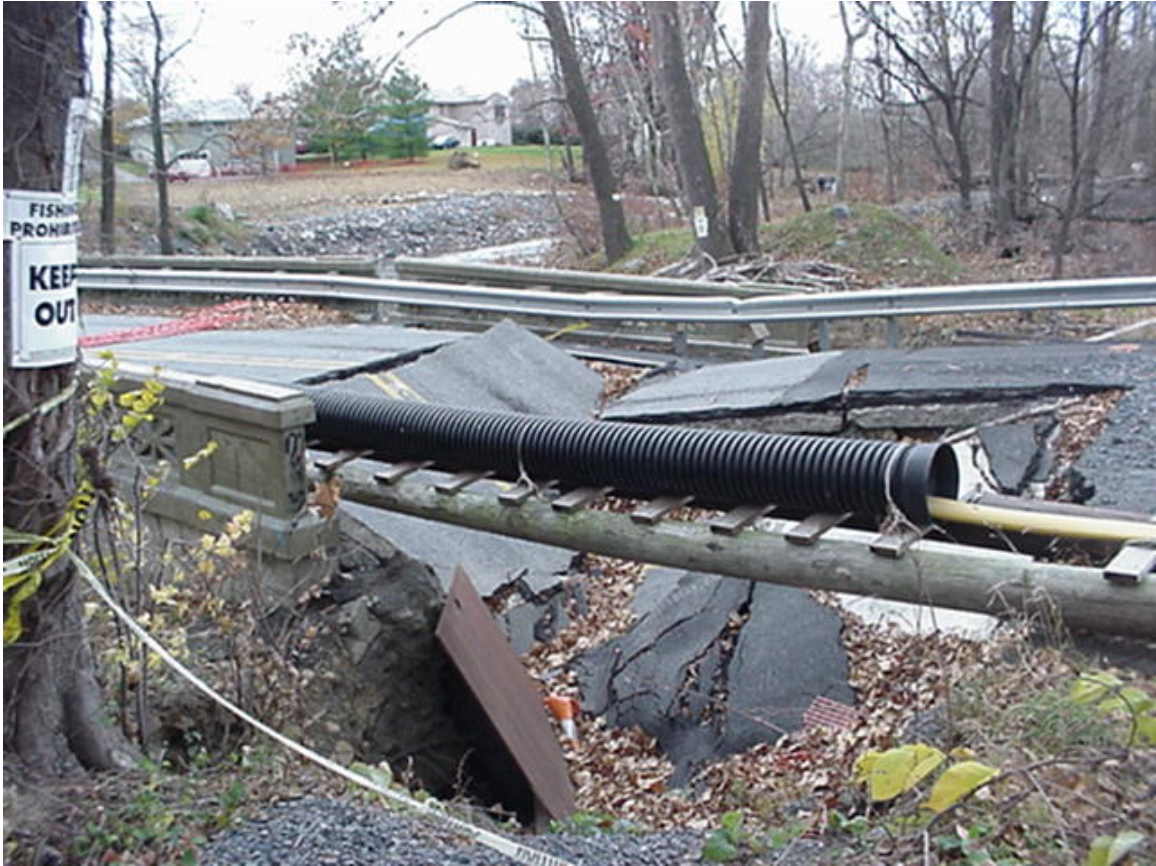
View looking southwest across the major distressed area of the bridge (north end). The eastern portion of the current EI survey area is in the background in this photo. The riprap and light brown fill in the background is part of a recent sinkhole restoration area.

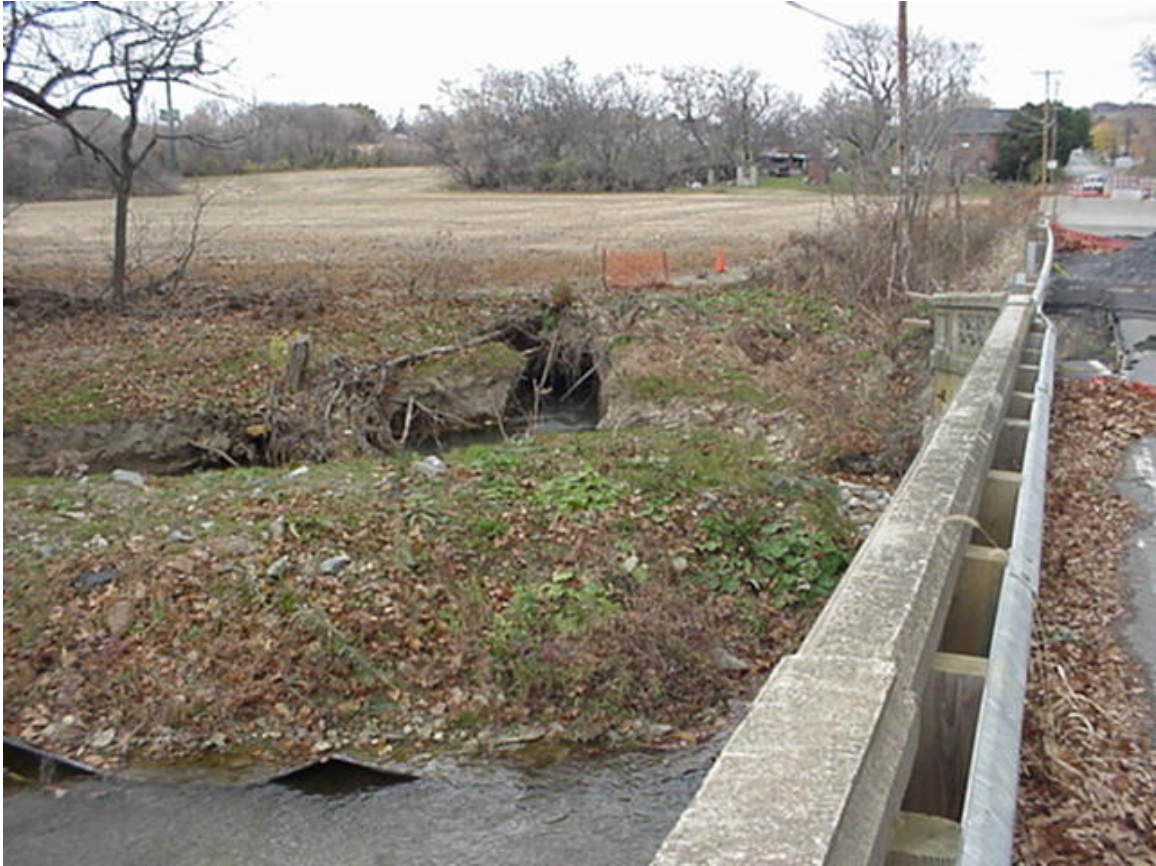
I performed a photo reconnaissance of the site using the digital camera. The sinkholes that I had observed several weeks before near the bridge area had distinctly enlarged and were draining a large amount of water out of the creek. Heather arranged the shutting off of the pumps in the Hercules Quarry for tomorrow in order for them to perform the EI survey in the creek bed.

View of the more recent, and enlarging, sinkhole area northwest of the bridge. Photo is looking north to northwest. The greatest distress to the bridge is immediately to the right of this area.

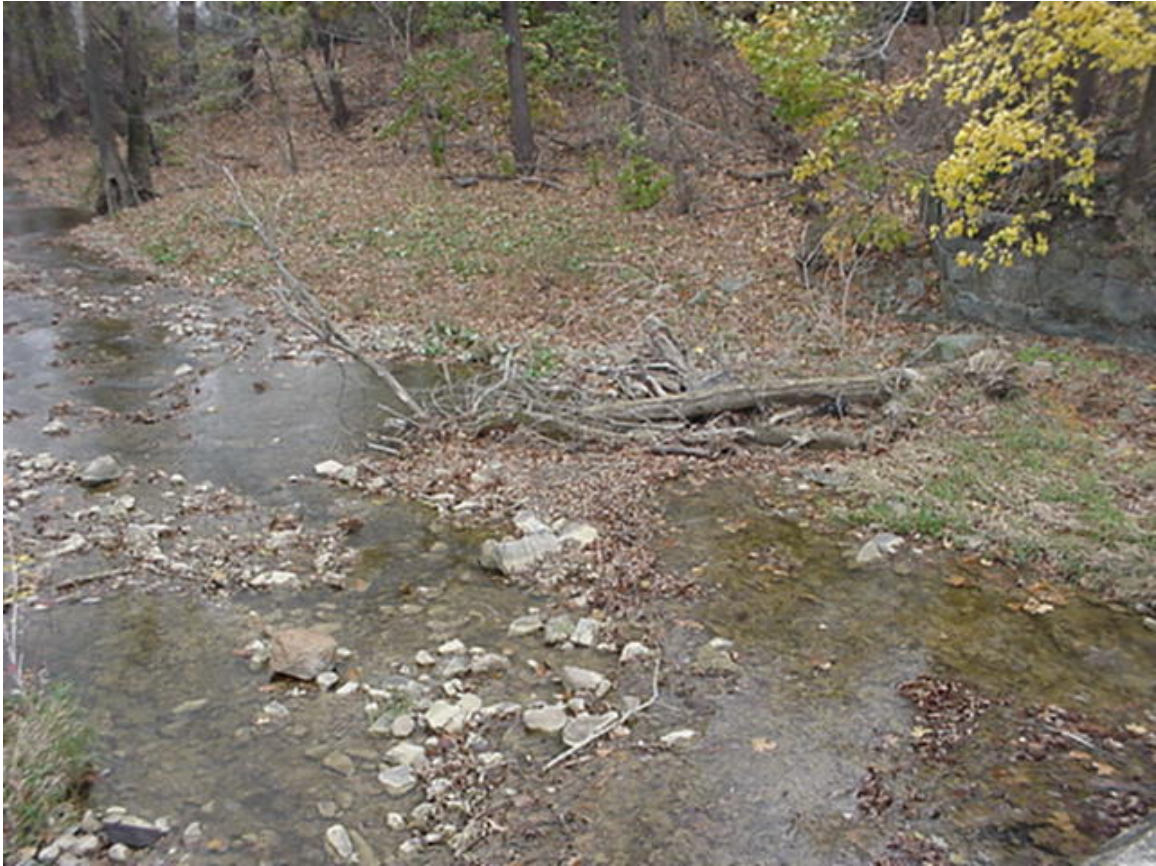
View looking southeast from the south side of the bridge towards an area where local residents reported the early development of a new sinkhole. Stream water seems to be eddying in the area immediately behind the tree debris.

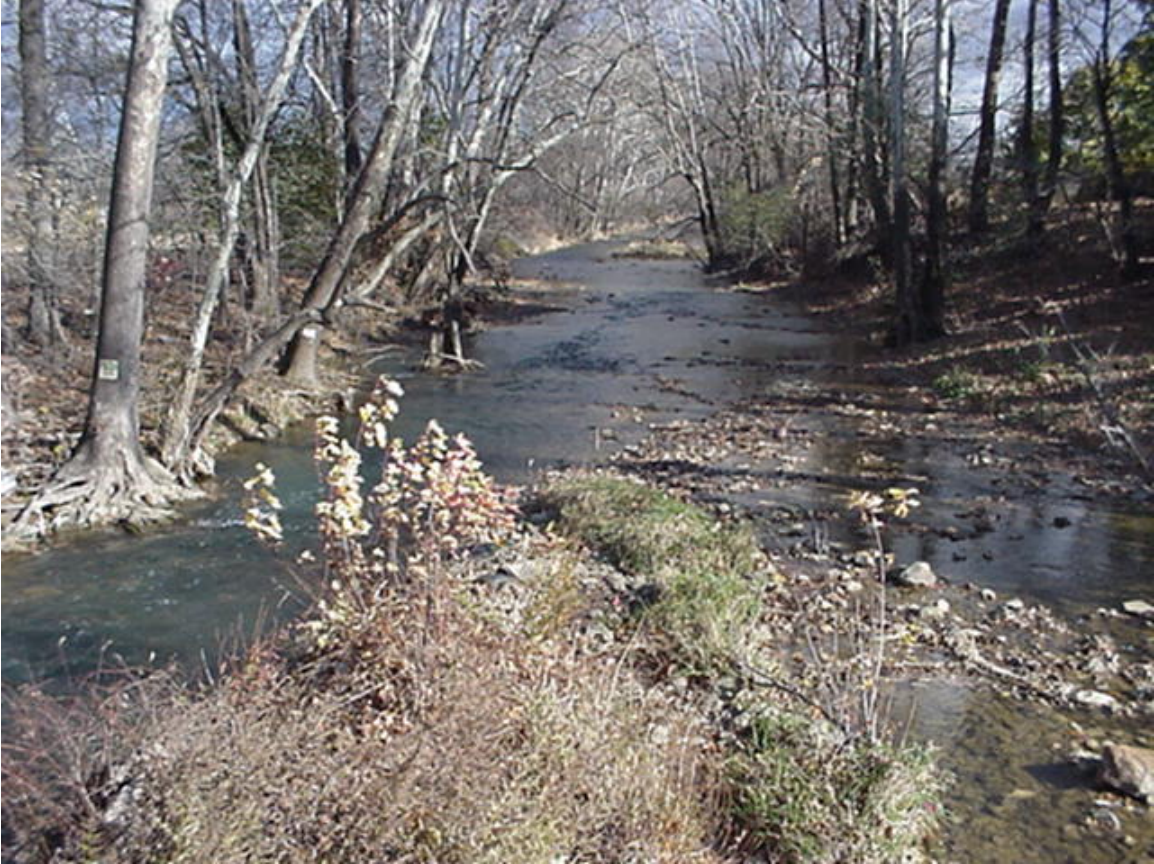
View looking east from the bridge showing the area immediately left of the area shown in the previous photograph looking downstream.

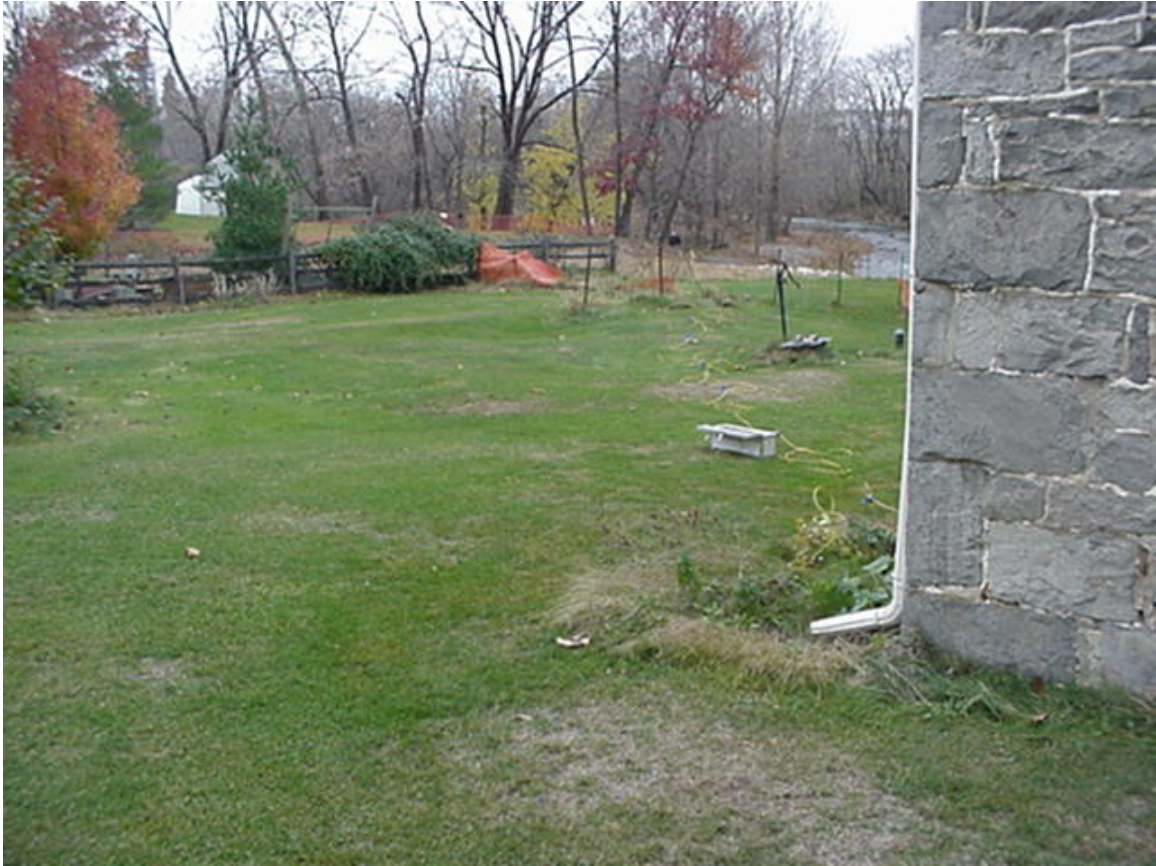
View looking northwest from starting point of the first EI survey point immediately west of the residence. The area behind the wood fence was the former large sinkhole area that had been remediated.

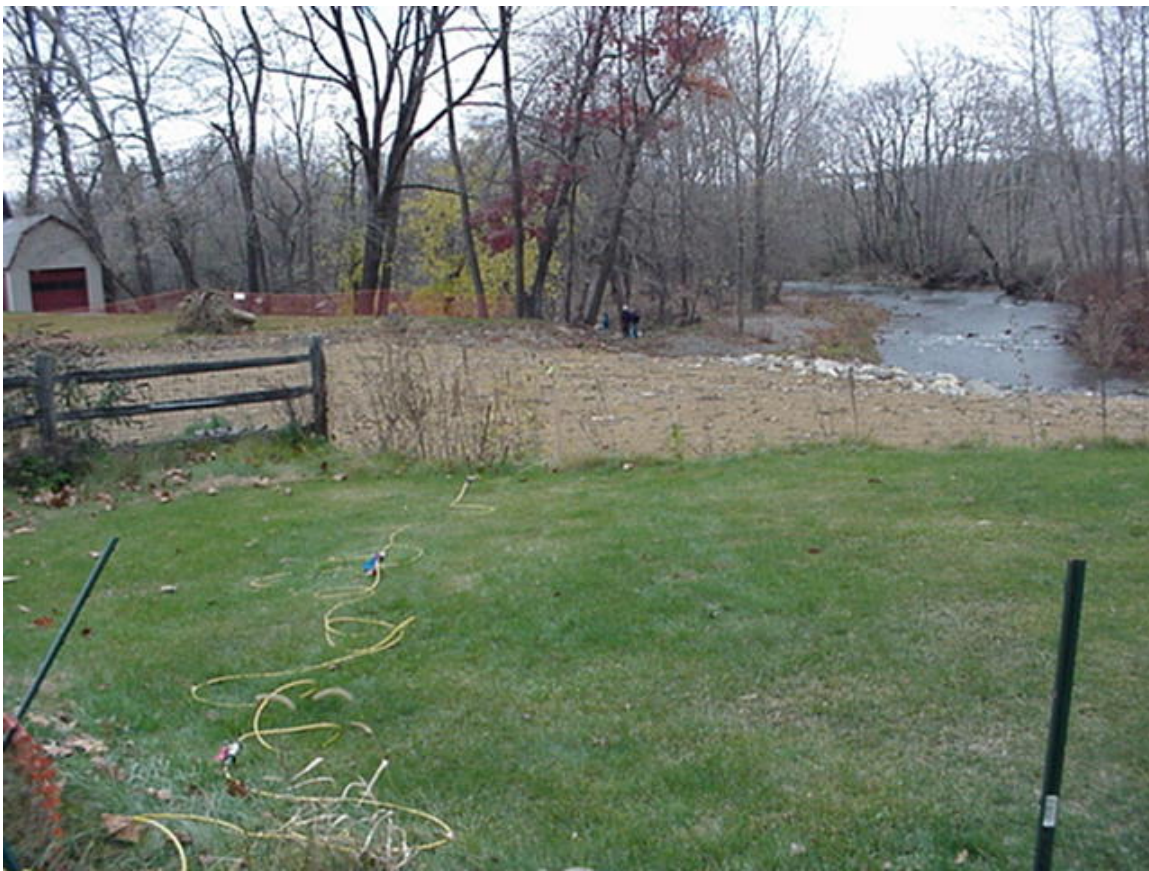
View along the first EI survey line immediately west of the area shown in the previous figure. The brown soil delineates the former remediation area.

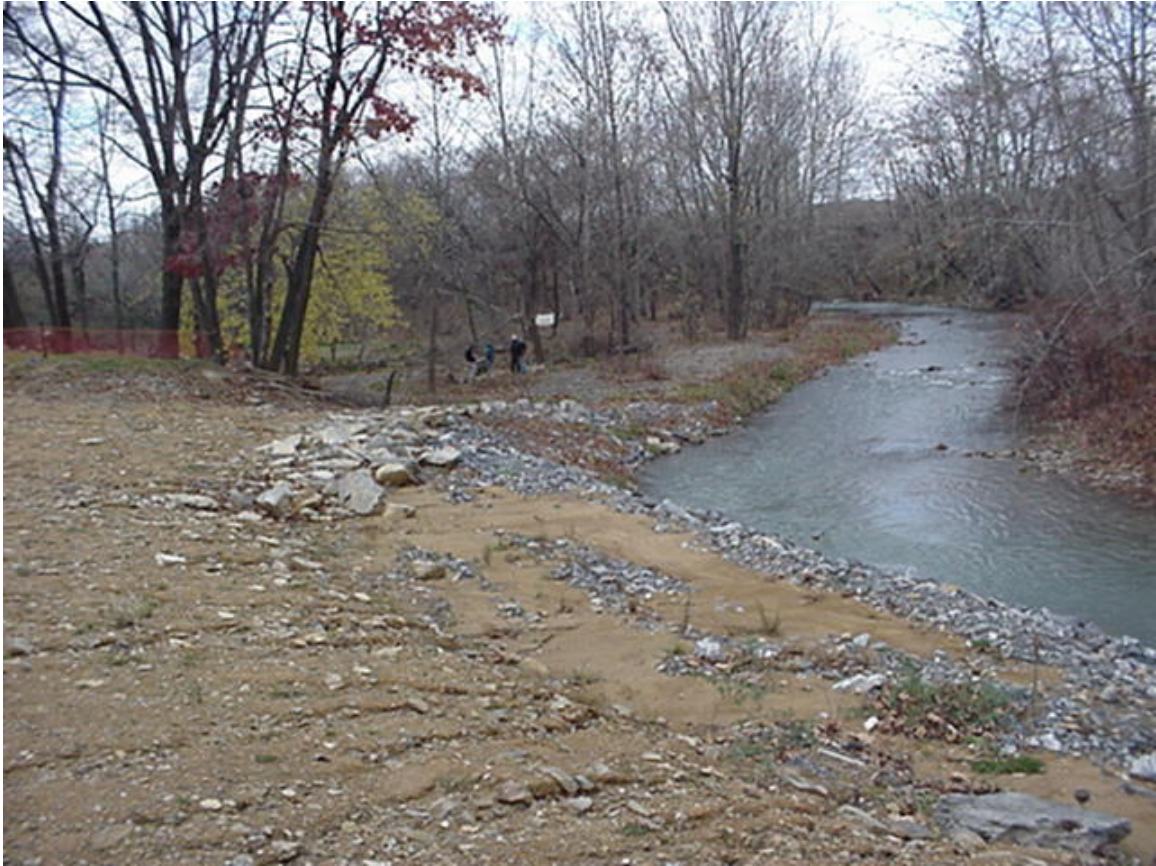
View further west from the 2 previous photos, showing the remediation area and area investigated today by the EI survey. The Route 33 bridge is behind the trees in the central part of this photograph.

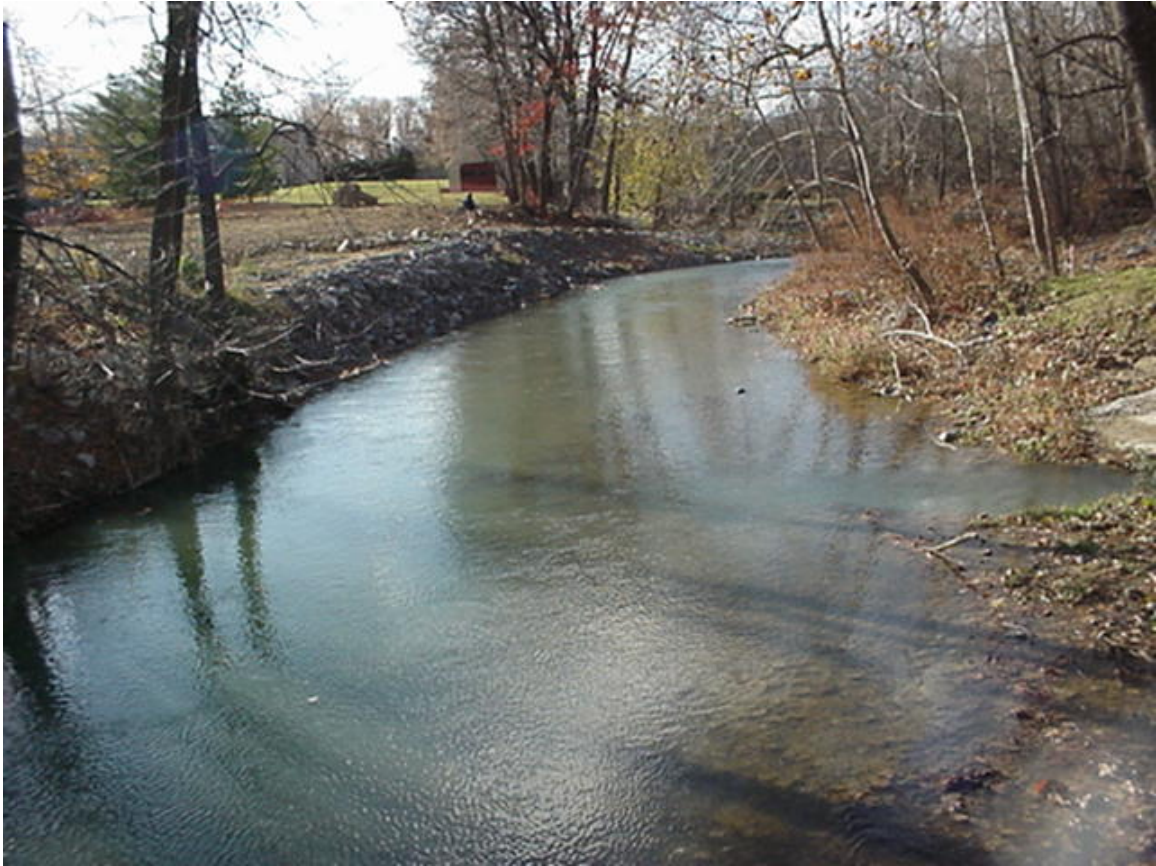
View looking southwest across the area shown in the previous photo from the other side of the creek.

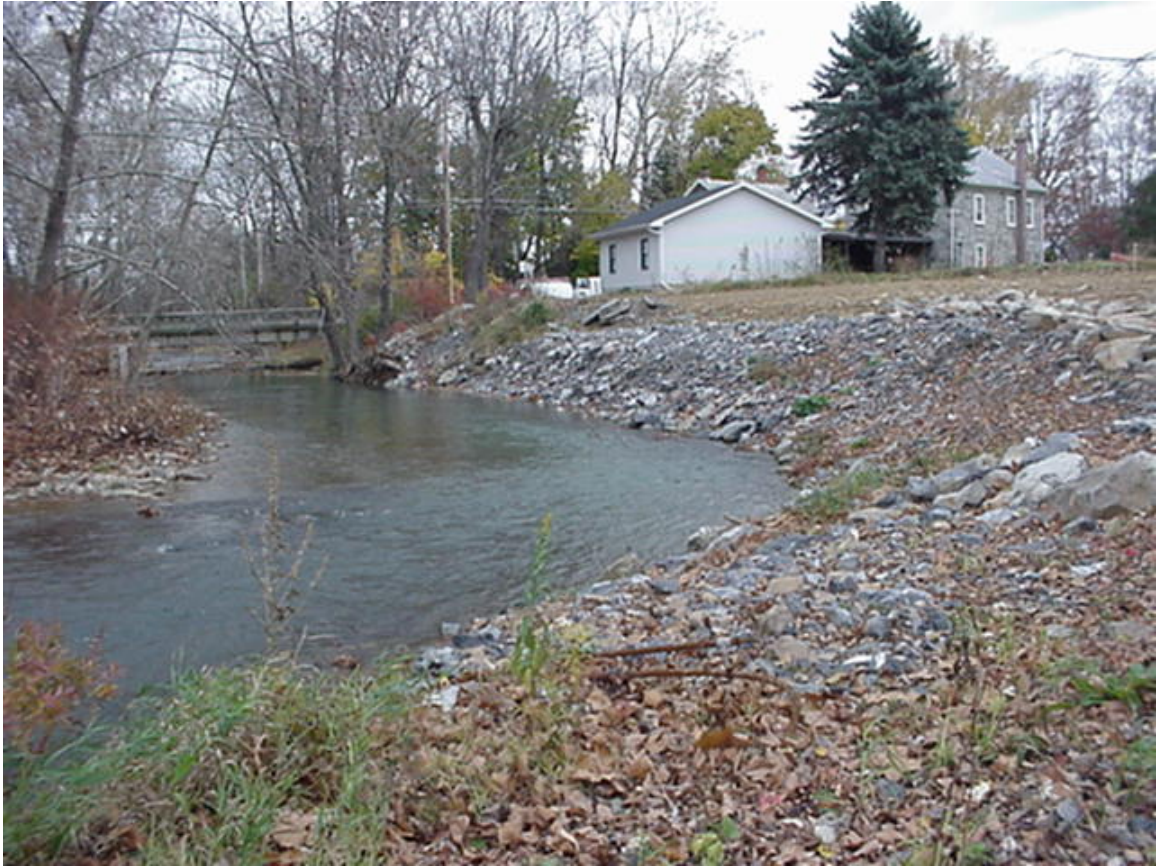
View looking east across the former remediation area shown in the previous pictures.

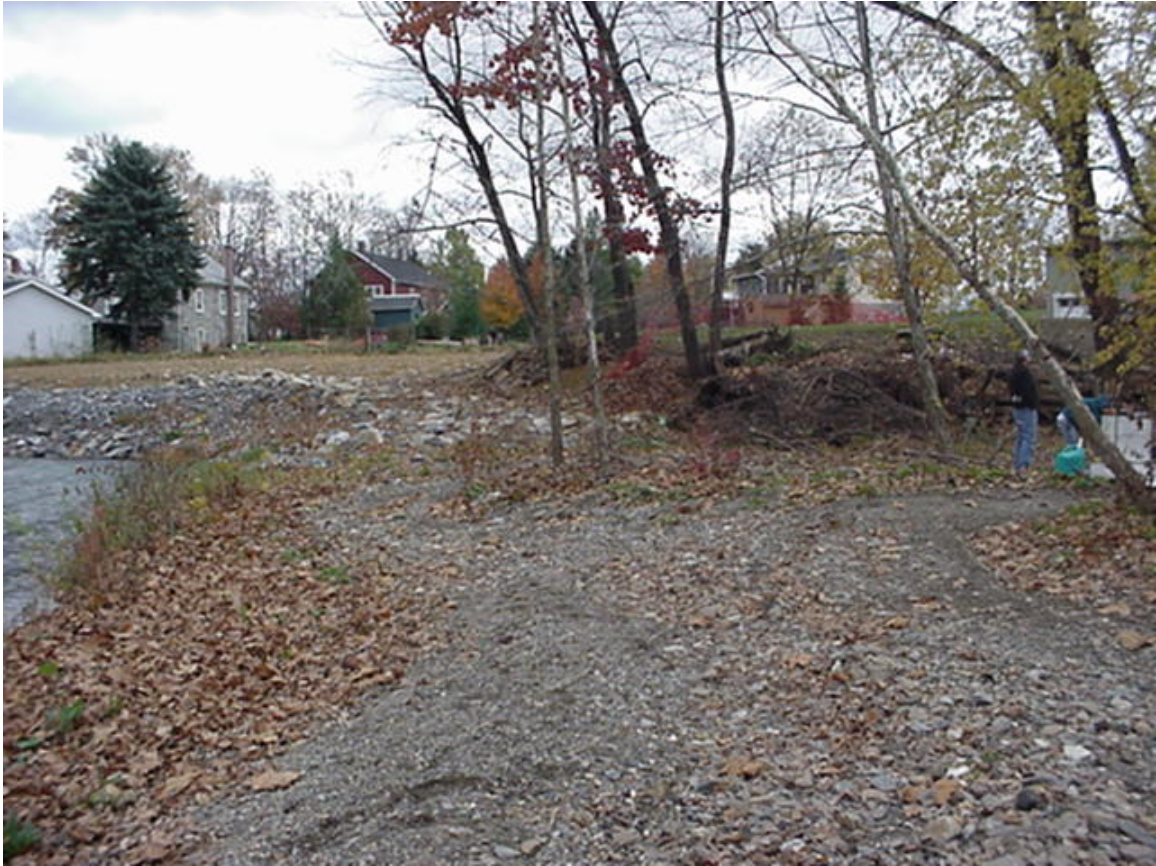
View looking southeast across the area shown in the previous photograph. The first EI survey line extended from behind the right corner of the gray house in the background to the right of the central part of this photograph. The second line extended from behind the garage to the left to the area shown at the far right of the photograph.

The EI survey lines have to be generally straight, therefore this criss-cross pattern provided the best coverage of this area.
